UVC: Florida Hospital Puts HVAC Maintenance Under A New Light

HVAC system downtime during coil cleaning can compromise humidity and temperature control, potentially leading to air quality or comfort problems. Florida Hospital has found that high-output ultraviolet-C lights installed in the AHUs reduce or eliminate coil-cleaning programs — yielding ongoing energy savings, a reduction in HVAC system maintenance, and the elimination of cleaning chemicals. The facility also reports IAQ and infection control benefits as the regimen continues.

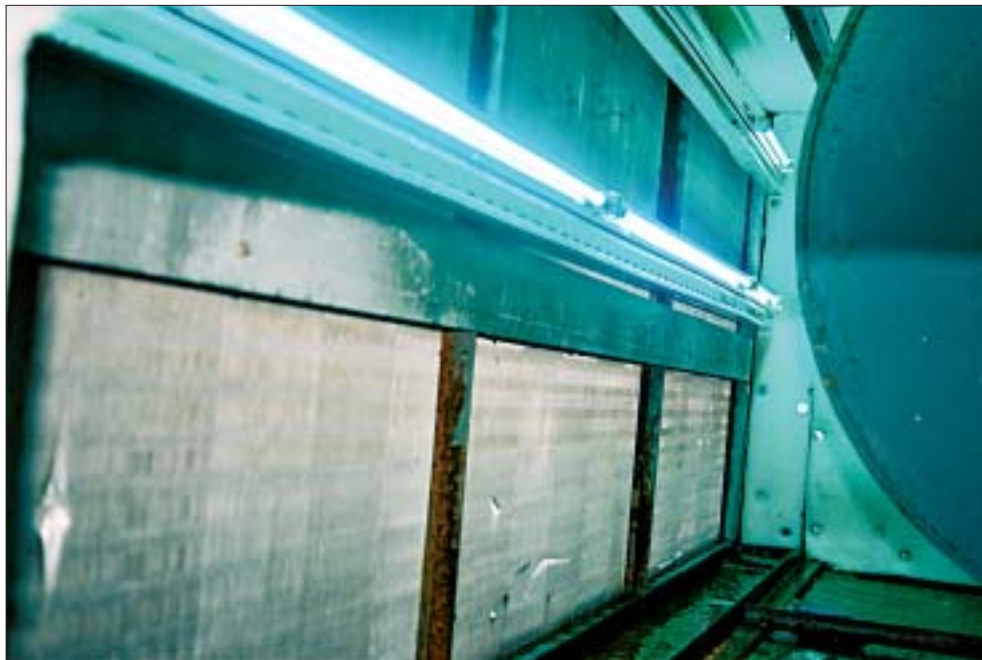
A recent UVC installation with a large coil.

After reviewing these initial results, the hospital administration agreed to expand the use of UVC. By the beginning of 2004, more than 100 AHUs in seven FH campuses were outfitted with the lights (Table 1), as well as some ceiling-mounted and portable air recirculating units. To obtain desired results in the AHUs, we generally follow the manufacturer's recommended guideline of 24 in. of UVC tube length for every 4 sq ft of coil face area.

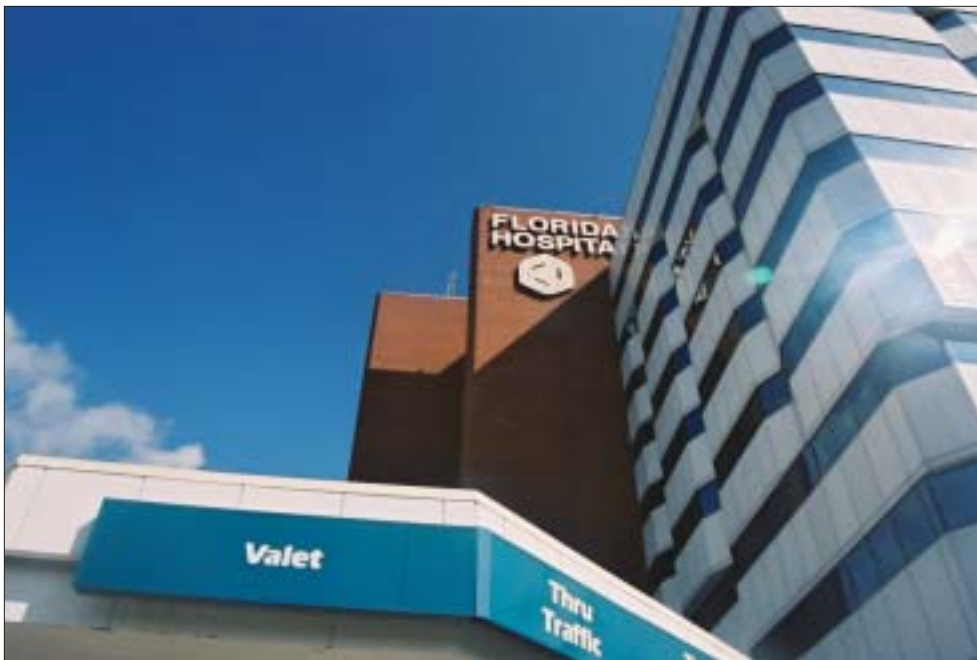
UVC lights have been used in facilities throughout the Florida Hospital system.
